FINAL REPORT:

UPPER MURRUMBIDGEE HABITAT REVIEW

May 2022

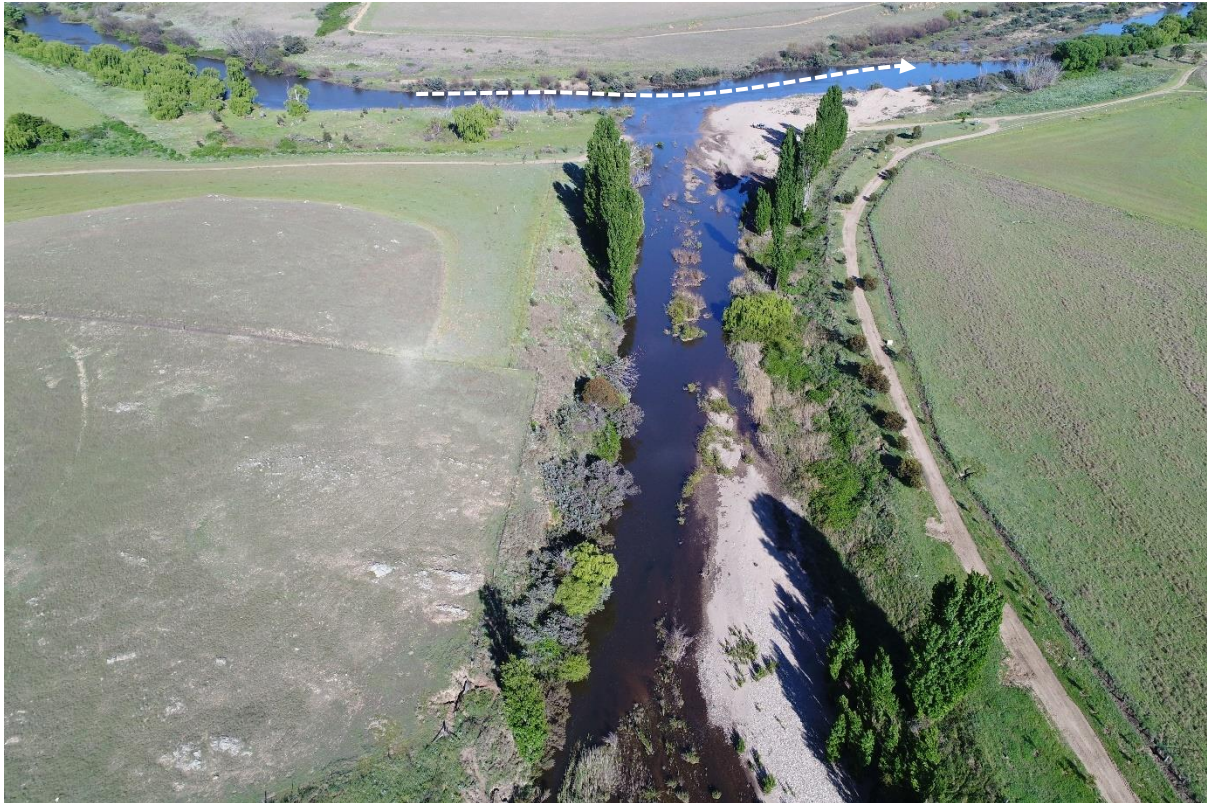
Figure 6. Drone image of the confluence of the Murrumbidgee River (top of image) and the Bredbo River, showing the abundance of sand being delivered by the Bredbo River to the Murrumbidgee River. The white arrow shows the direction of the flow (Photo: Hugh Allen)

Figure 7). Upstream of the confluence with the Bredbo River, the Murrumbidgee River is relatively narrow (<50m), but immediately downstream of the confluence the channel widens to ~90m. Riparian cover is lacking, and mostly in the form of sparse shrubs and some willows. Under low flows, it is likely that this section would act as a barrier to upstream fish movement, because of its lack of depth or flow refuge. Impacts of the sedimentation are seen for the next 4 km, with much of that reach heavily sand affected. There is an absence of riparian vegetation in many areas along the reach and instream wood loads are low.

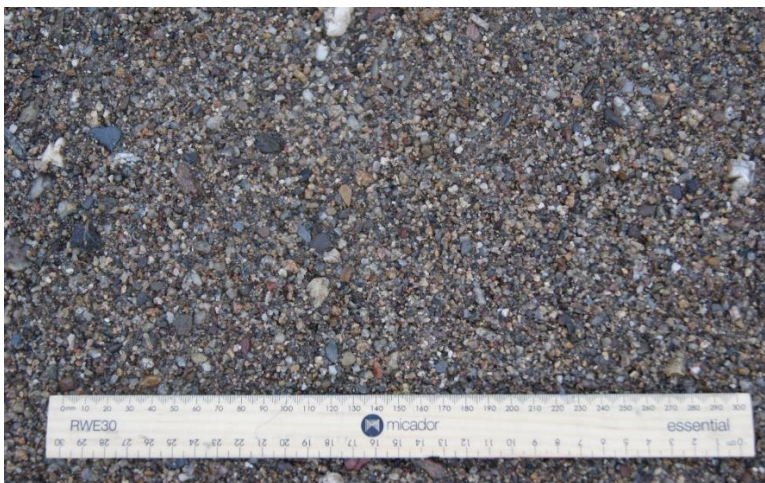
Figure 7. Typical composition of the bedload of the Bredbo River at the confluence with the Murrumbidgee River (Photo: Ben Broadhurst)

The Bredbo River is one of the key tributary sources of sediment in the UMDR. Inputs from the Bredbo River tend to be dominated by larger sand and smaller gravel substrate types (

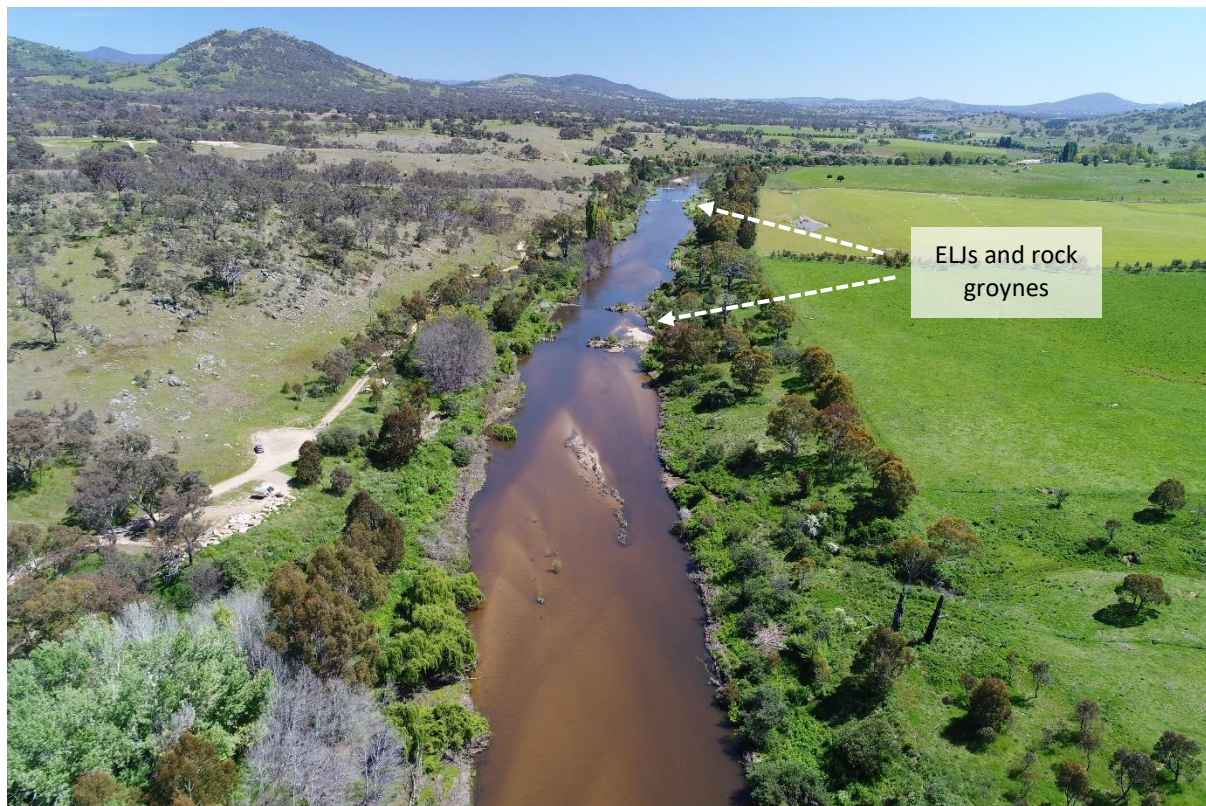
Figure 8. Tharwa reach of the Murrumbidgee River looking downstream towards the engineered log jams. (Photo: Hugh Allen)

The 4.3 km Tharwa reach is the most sand affected reach in the UMDR (GHD 2011a). The Murrumbidgee River here is between 40 - 90 m wide and has varying riparian condition, though generally at least some vegetation present. Sediments here are typically sand to small gravel (Figure 9). Despite the high level of sedimentation, the channel still shows some depth diversity with shallow, uniform areas over sand waves and with a deeper thalweg and deeper areas adjacent to constructed features such as the engineered log jams, and the rock groynes. There is a general lack of hard substrate and very little in the way of edge cover for fish. During low and moderate flow, the channel

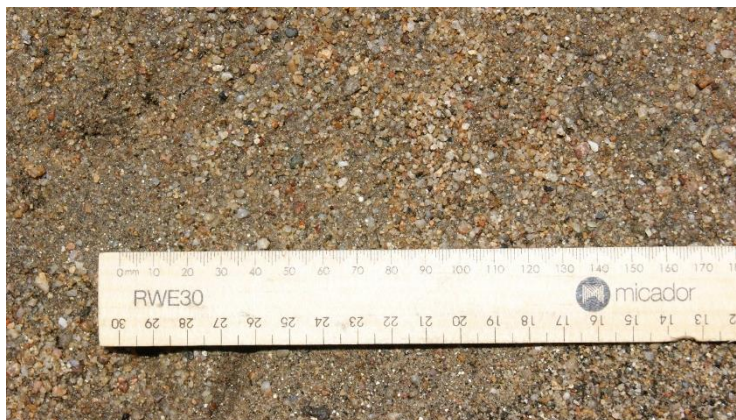
Figure 9. Typical composition of the bed load of the Tharwa reach of the Murrumbidgee River (Photo: Ben Broadhurst)

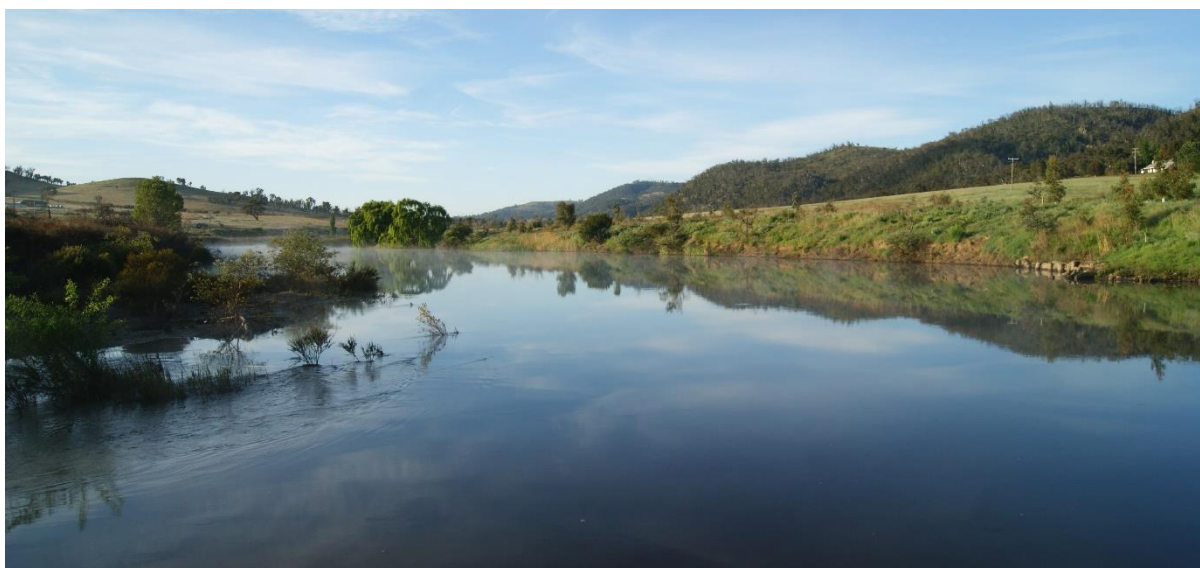
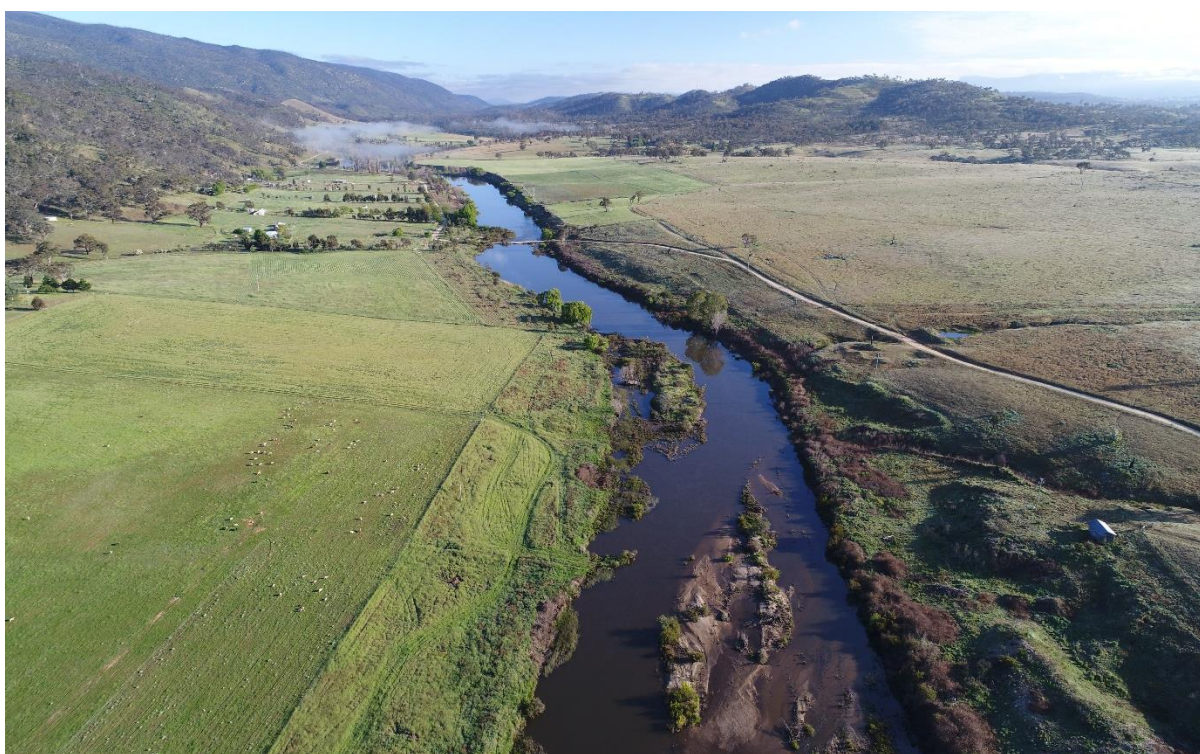
Figures 10a and b. The Bumbalong Reach which has some depth diversity with deeper pools and some instream sand bars. There is little habitat diversity through this reach however, with no riparian zone and no large, instream wood.

The reaches at Bumbalong and Gigerline are less sand affected than those at Tharwa. The reach at Bumbalong is much deeper than other reaches and there is some diversity with deeper pools and a deep thalweg (Figures 10). There are intermittent sand bars within the channel that are starting to be colonised with vegetation. Although the reach is much less sand affected than others such as the Tharwa reach, there still remains a lack of habitat diversity. Riparian vegetation along the reach is very limited with little overhanging or instream vegetation. There is also an absence on large wood within the reach.

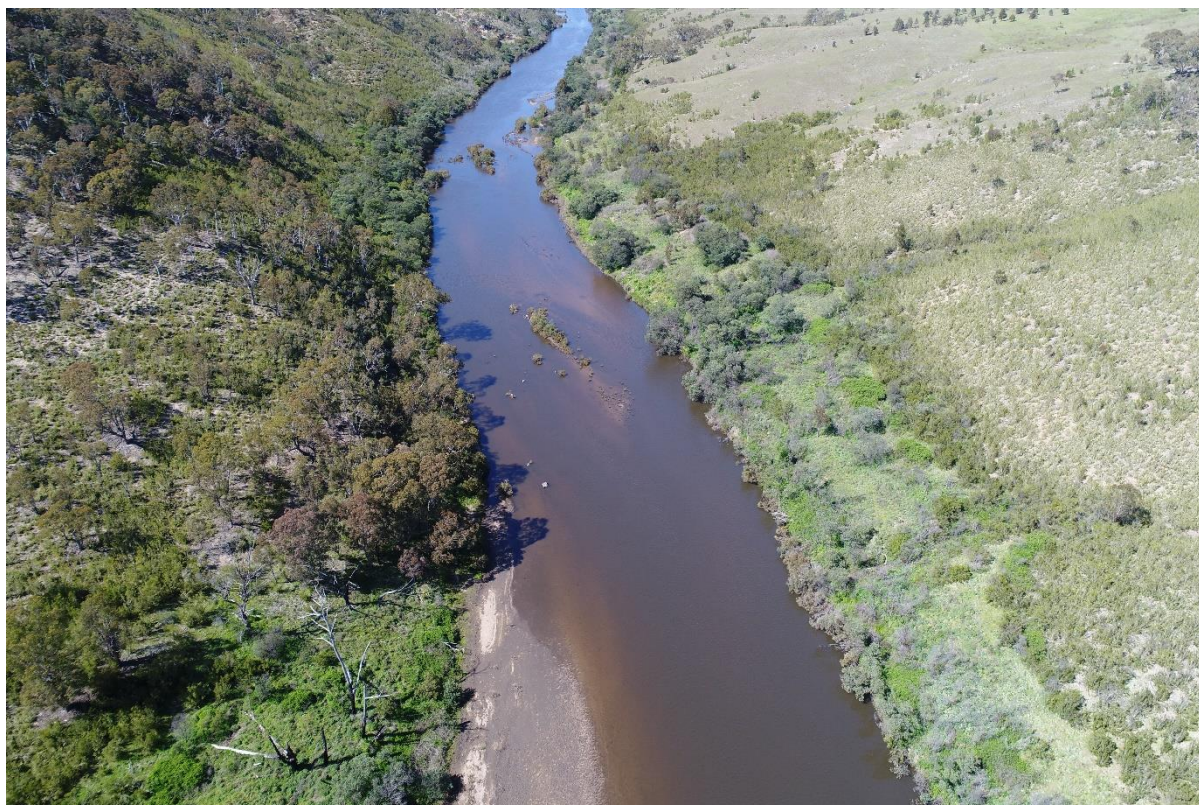
Figure 12. Aerial view of the Gigerline reach. A small sandbar can be seen in the mid-ground but in general the reach has few sand bars and benches.

The Gigerline Reach is mapped as gorge using the RiverStyles Framework and like the Bumbalong Reach shows minor impacts of sedimentation compared with other reaches. Through this reach, there is some depth diversity with deeper areas as well as some shallow areas where sand has been deposited however, overall, large sand bars and benches are not present. Bed load sediments in this reach are also different than in sand affected reaches. In the Tharwa Reach for example, bed load sediments range from sand to small gravel while in the Gigerline Reach, bed load sediments are predominately coarse gravel with most sand sediments likely to have been transported downstream due the higher energy environment within the gorge. (Figure 11). As with other reaches, riparian vegetation and instream large wood are lacking.

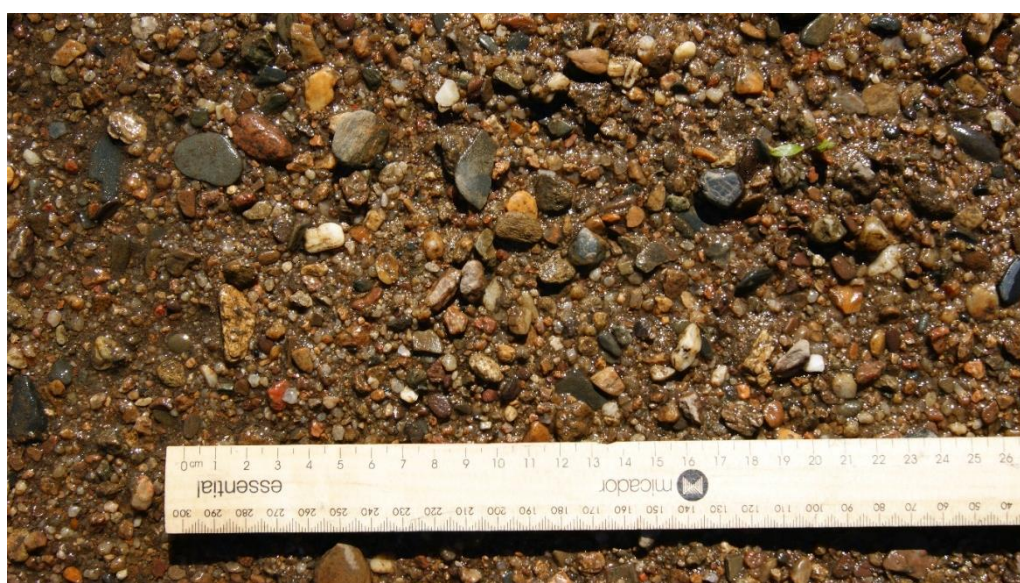
Figure 11. Bed load sediments from the Gigerline Reach which are predominately coarse gravels.

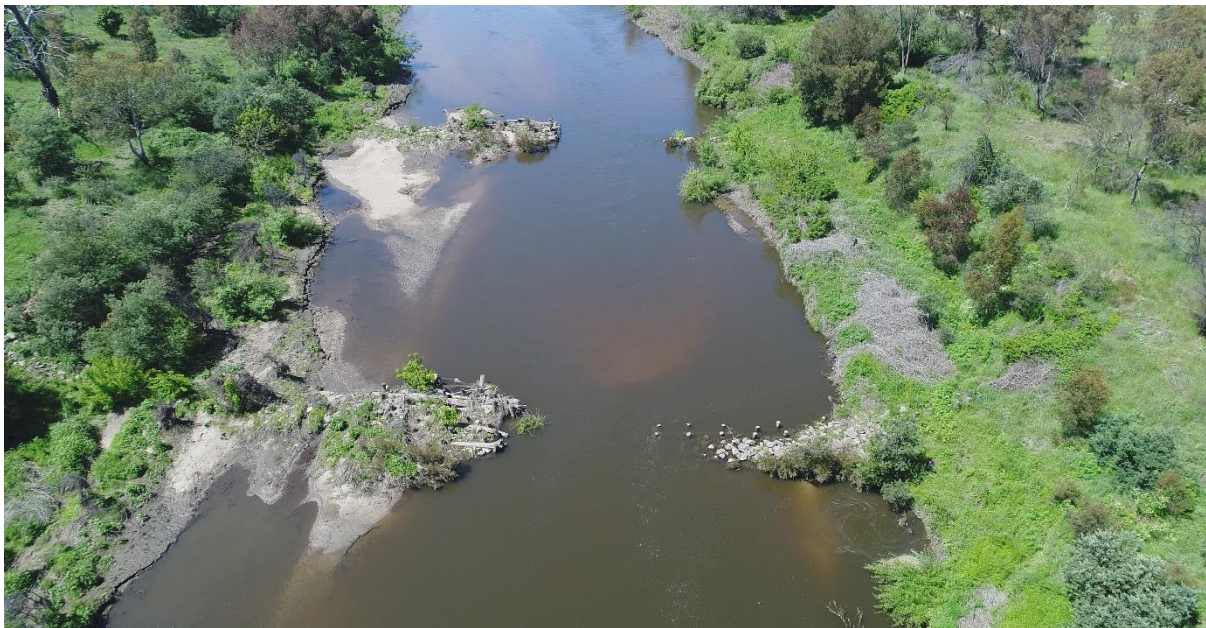
Figure 13. Previously installed engineered log jams (part of the 2011 GHD work) and an enlarged and realigned rock groyne (originally part of the early 2000s work) within the Tharwa Reach. (Photo: Hugh Allen).

- Permanent scour holes developed and were maintained at the tip of the deflectors however, deflector spacing along the banks was too great because individual scour holes did not link up.
- Snags that were re-instated between deflectors were buried in sand because they were placed too far from the tip of the deflectors.
- Deflectors at the upstream end of the group were prone to become swamped with sand because of shifts in the position of the thalweg.
- The excavated pool was completely infilled with sand.

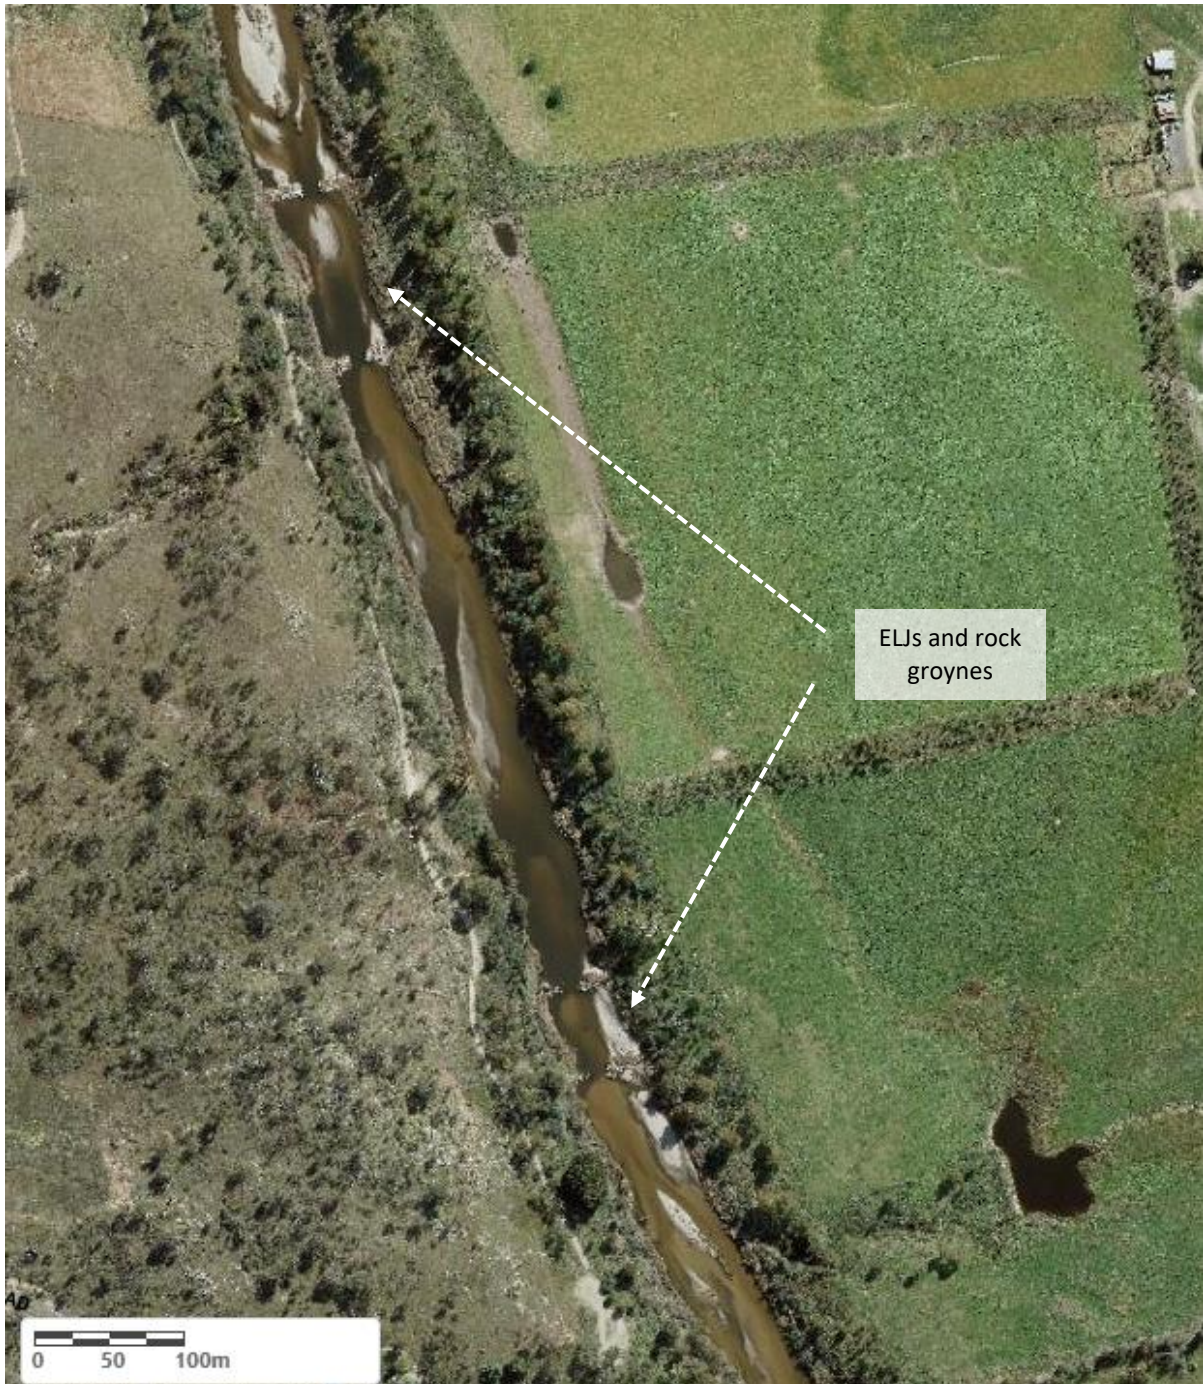
Figure 14. Aerial imagery of the Tharwa reach showing the 2013 engineered log jams, paired to enlarged rock groynes (bottom pair of structures) and the 2018 engineered log jams (top pair of structures) in February 2021 (Photo: ACT Government)

The installation of waterway structures in the Tharwa reach in 2000, 2013 and 2018 have had some definite positive impacts on channel heterogeneity by forming deeper sections of river, with slower flow velocities, and enough so to promote the inhabitancy of adult and juvenile Murray Cod at this site (Lintermans 2004; ACT Government unpublished data). Aerial imagery of the site from February 2021 shows that the impacts of these structures are relatively spatially restricted (< 150 m), with homogenous shallow sand habitat above and below the influences of these structures (Figure 14).

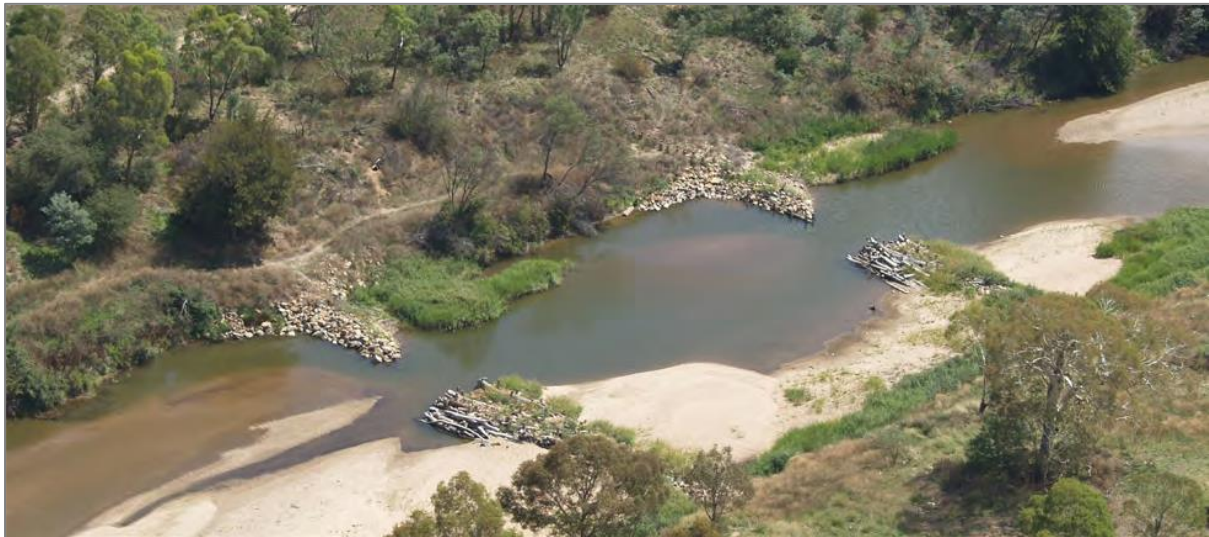
Figure 17. Aerial image of the engineered log jams at the Tharwa sand affected reach (Photo: ACT Government).

Following on from the above works, a second rehabilitation effort along the Tharwa sand affected reach was undertaken in 2013, focussing on two engineered log jams (ELJs) and two large rock groynes, along with riparian planting (Figure 17). Bathymetry surveys after construction found that the new deflectors had increased depth in the vicinity of the structures from ~ 0.35 m - up to 2 m (ACT Government unpublished data). Fish surveys conducted prior to the 2013 installation found some juvenile Murray Cod present, mostly associated with the existing rock groynes structures built in 2000. Monitoring following the 2013 installation found approximately twice as many Murray Cod present compared to earlier surveys (ACT Government unpublished data).

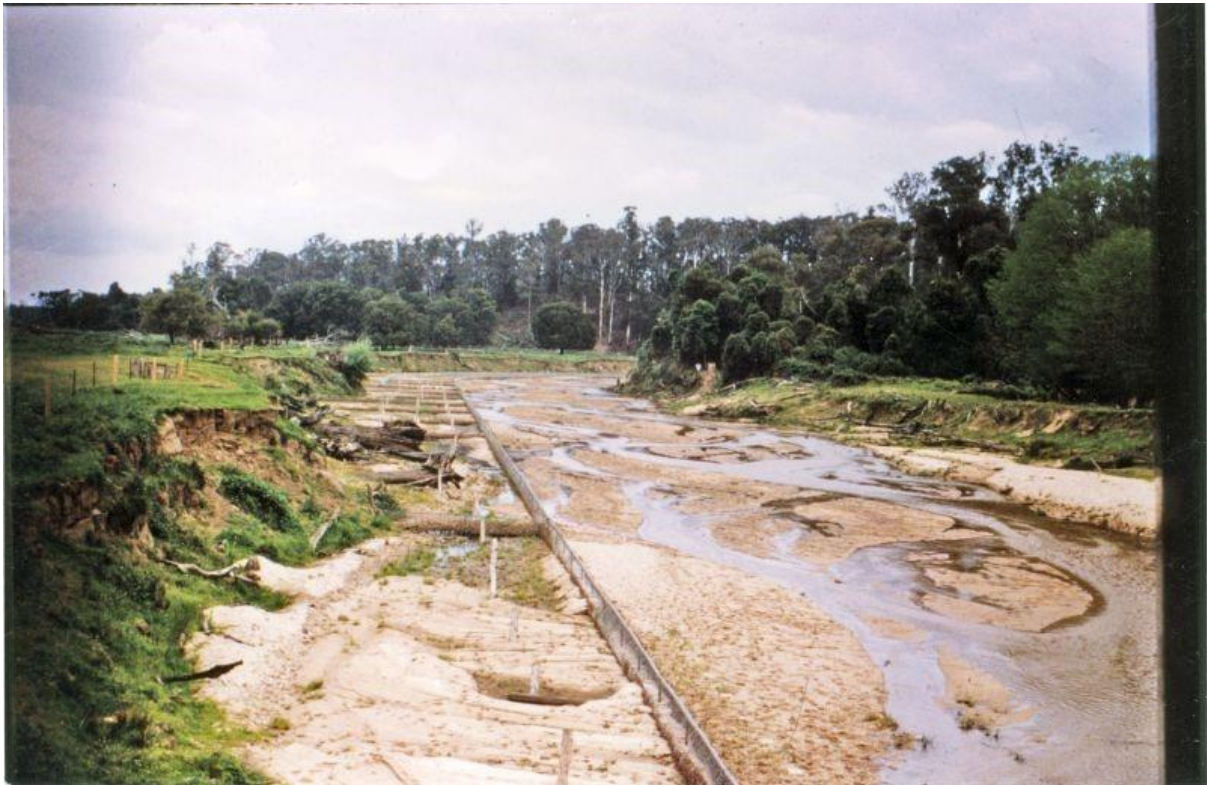
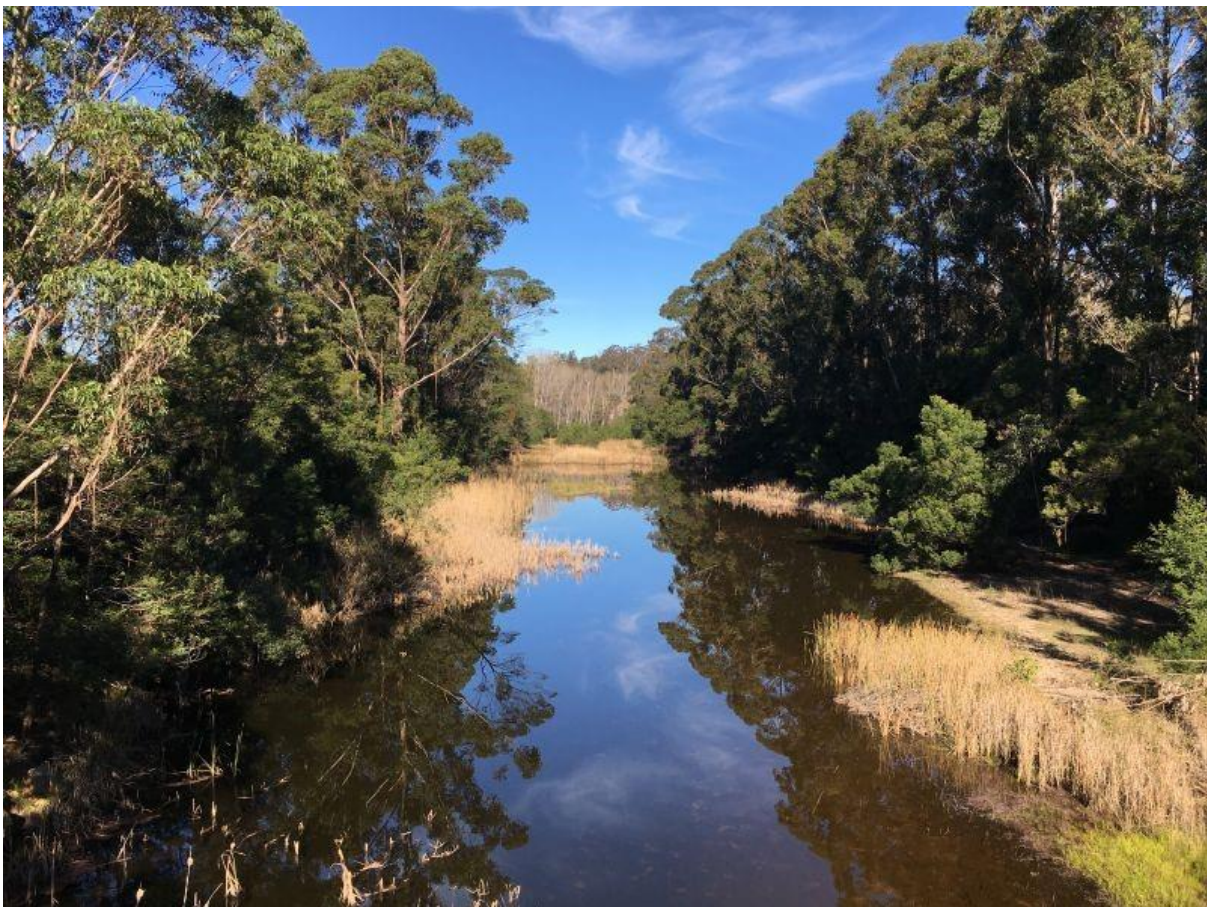
Figure 18. Cann River in the 1970s (above) and in 2000 (below). (Photo: Rex Candy EGCMA).

Pile fields are lines of timber logs installed vertically into the bed of the channel that can have multiple benefits for waterway management including capturing and storing sediment. The use of timber provides a porous material that allows for low velocity through flow assisting with sediment deposition both upstream and downstream of the structure. Pile fields work most effectively when combined with revegetation and care should be taken to avoid common failure mechanisms such as outflanking and undermining (DSE, 2007).

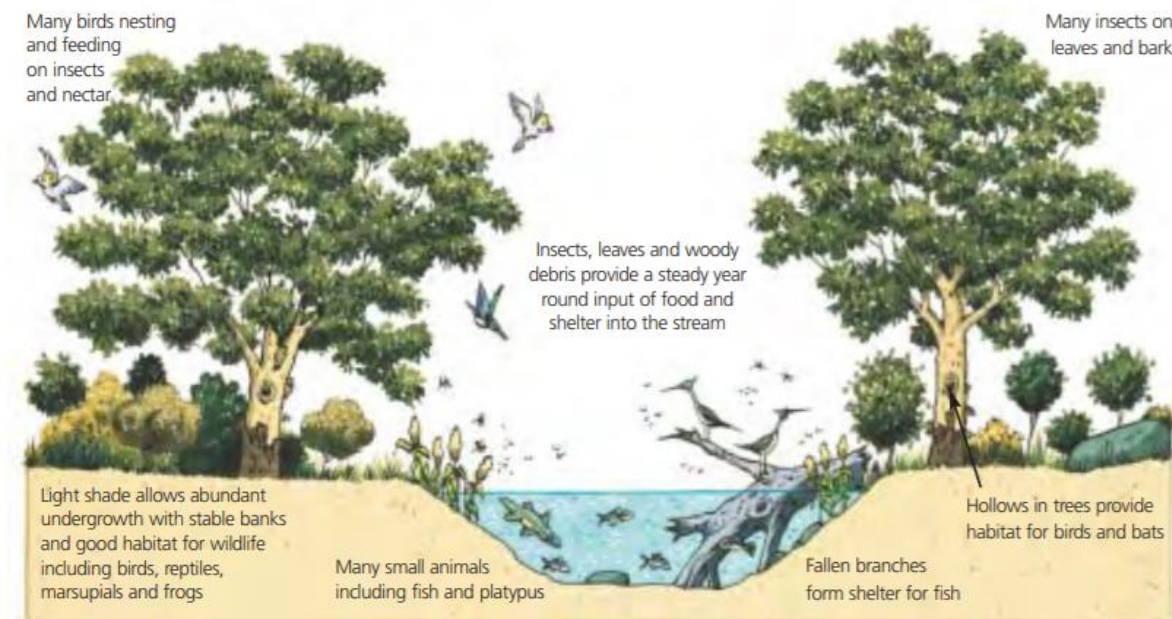
Figure 21. The benefits of native vegetation in riparian areas (from Lovett and Price, 2007).

Riparian revegetation, including emergent aquatic vegetation can be used in conjunction with other sand management measures to improve habitat values within the waterway. The vegetation acts as a filter for sediments and nutrients entering the waterway from overland flows. Shade from riparian vegetation also helps regulate water temperature and reduce the likelihood of algal blooms (Lovett and Price, 2007; DELWP, 2018), while providing habitat areas in and out of the water (Figure 21). Riparian vegetation also plays an important role in providing the ideal conditions for macrophyte growth whose abundance has been correlated with spatial variations in fish distribution. Macrophytes in turn provide general habitat, refuge from high velocity flows and predators and in some cases, also provide a food source for some native fish (Pusey and Arthington, 2003). Furthermore, a diverse and healthy riparian zone plays an important role in aquatic food webs, particularly in upland streams where the majority of trophic inputs are derived from terrestrial environments. The terrestrial inputs to the aquatic system may also stabilise food webs by providing a buffer against short-term changes in the supply of food instream (Pusey and Arthington, 2003).

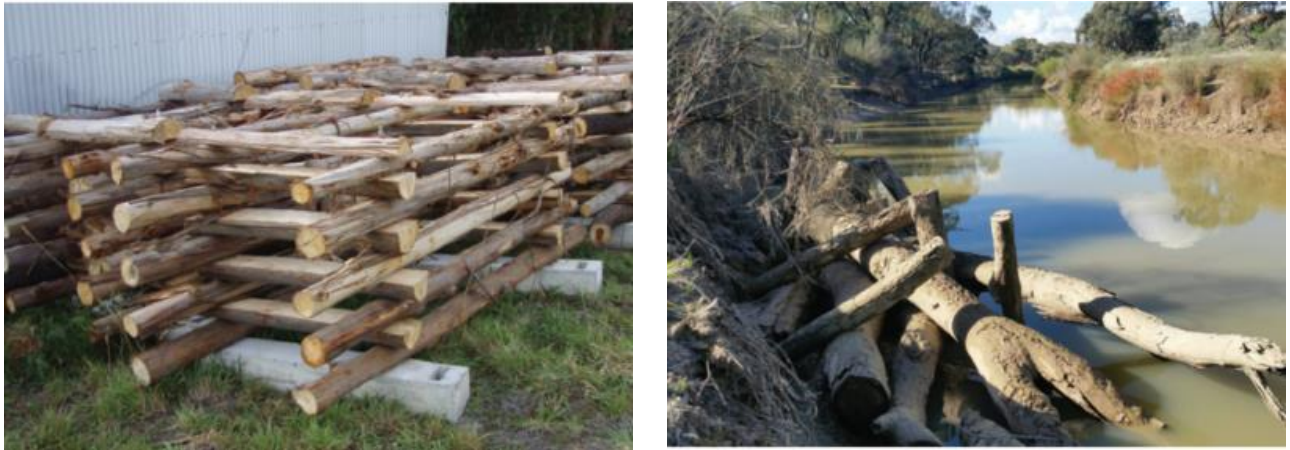
Figure 22. Types of large wood installation used for habitat improvement. (L) fish hotel, (R) large wood arrangement using two root balls and four large trunks. Source: ARI, 2019

Fish hotels are constructed using small timber branches arranged in a square or rectangular shape which are connected by metal rods and are occasionally weighted down with concrete or anchored into place with piles. Other large wood arrangements include using single large whole trees, arrangements that include the key branches trunk and root ball, arrangements that retain just the root ball and 1 m of trunk and arrangements where the crown and root ball are removed but the trunk and key branches remain intact (ARI, 2019).

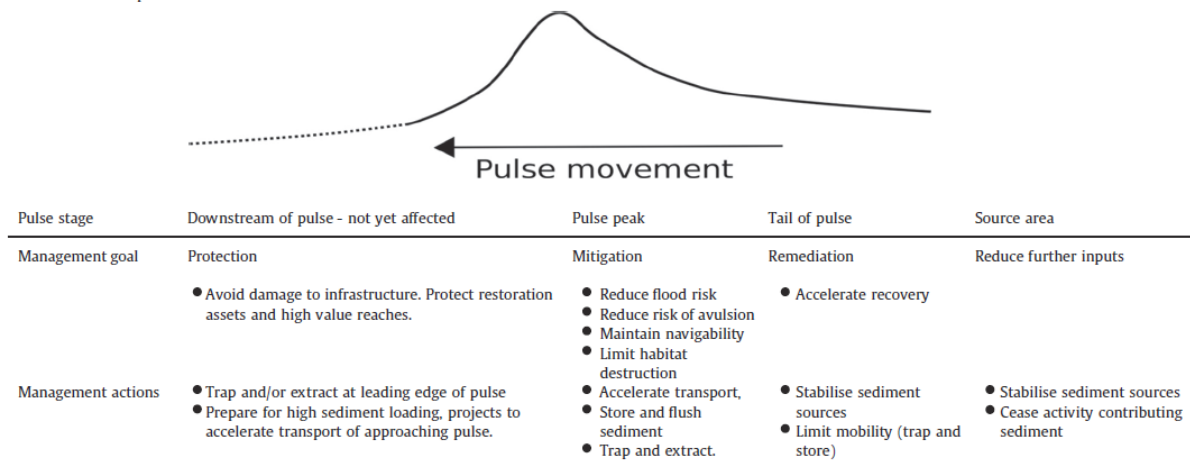
Schematic of the pulse

Figure 23. Generalised management framework for sand affected rivers (Sims and Rutherford, 2017).

Sims and Rutherford (2017) outlined a decision framework for management of sand affected waterways, which identified that to be successful the management action needs to consider the management goals as well as the location of the sand slug (termed 'pulse'), Figure 23.
